Rice Drilling D, LLC

NSPS Subpart OOOOa Annual Report

Rice Drilling D, LLC NSPS Subpart OOOOa Annual Report

Big Dawg 1HA, 3HA, 5H, 7H Leaking Components Report

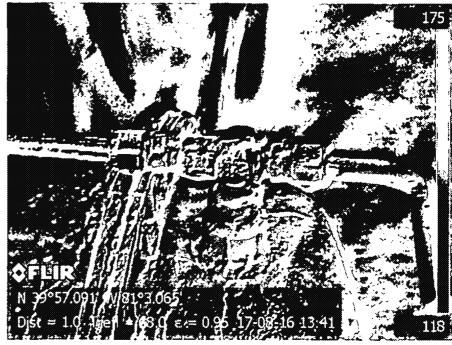
HAYM-20180816-004IR Repaired

Location: 1H GPU Run 2 High Low Stainless Fitting

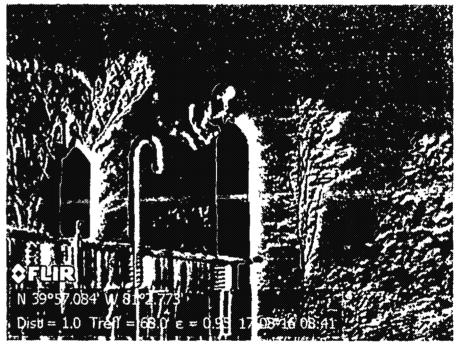
TACO-20160816-001IR Leaking

Location: Fuel Skid Dump Control for Concentrate Separator

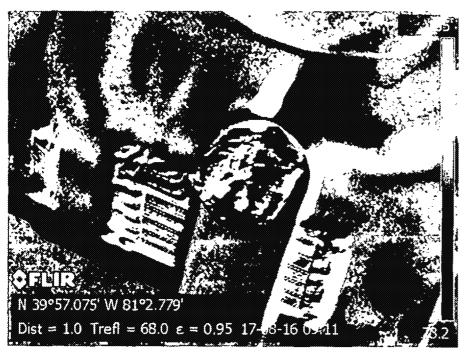
TACO-20160816-002IR Repaired

Location: 1H GPU Run 2 Piper Valve Grease Fitting

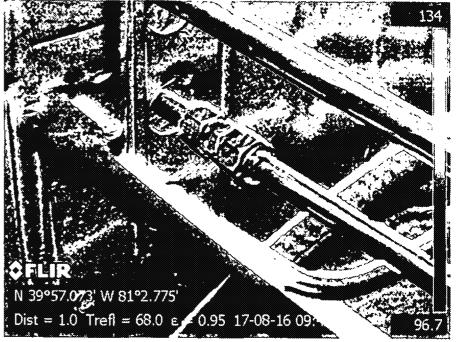
TACO-20160816-006IR Leaking

Location: 3H GPU Run 1 Fuel Gas Stainless Fitting

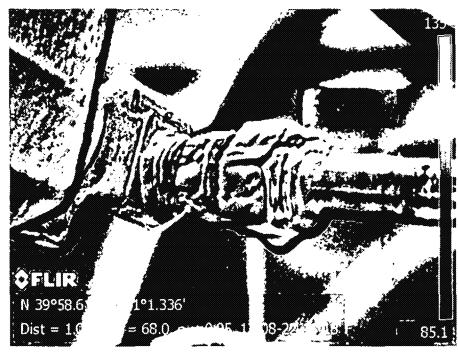
THUN-20170822-003IR Repaired

Location: 4H GPU Run 2 Solenoid Stainless Fitting

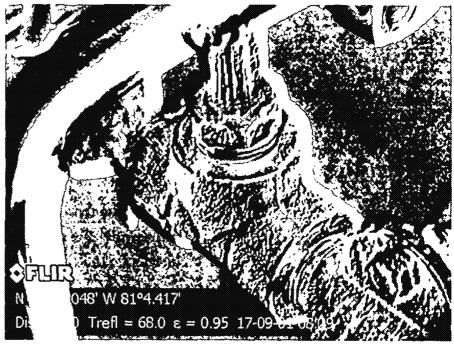
### TUNA-20170822-008IR Repaired

Location: 3H GPU Run 2 Fuel Supply ½ Inch Nipple

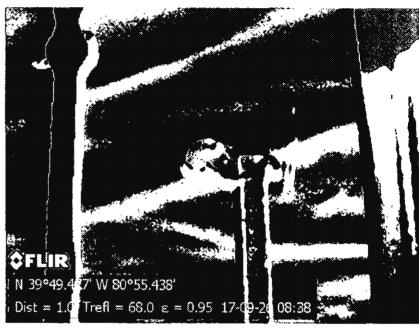
Flash Separator Back Pressure Regulator Repair

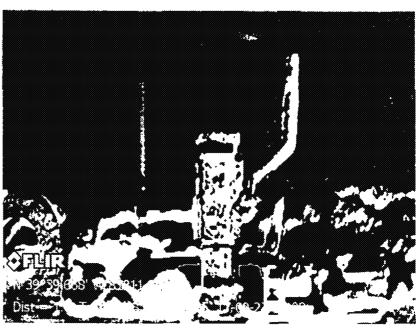
Inlet Filter Separator Bleed Valve Repair

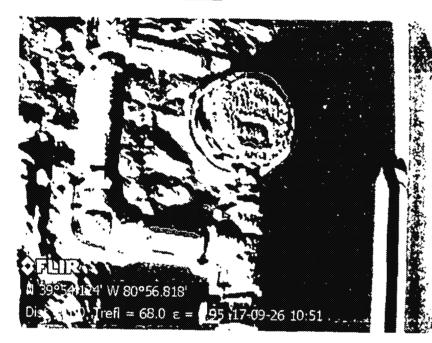
STATION	Ceru	<i>\$</i> Y						
ON-SITE CONTACT	J, C, J	OYNOU	1	•				
DATE TESTED	9-26-17		START TIME 10:25 END TIME 11:15					
SKY CONDITIONS	CLEAR	AMBIENT T	EMP	770	WIND SPEED	1 MPM		
CAMERA MODEL		GFX	320					
CAMERA ID NUMB	ER	SN 7	490010	9				
CAMERA CERTIFIC	ATION DATE	2/27	//2017		· · · · · · · · · · · · · · · · · · ·			
DAILY VERIFICATION	ON DATE	9-	26-	2017	***************************************	······································		
MAXIMUM VIEWING	G DISTANCE	25 fe	et	<i>Landin</i>				
MONITORING COM	PANY	RICI	POSEI	DON MIDSTRI	EAM	• • • • • • • • • • • • • • • • • • •		
MONITORING TECH		- Јон	N ROW	<u> </u>				
TECHNICIAN CERT	w.w. x	YES			Ø			
TECHNICIAN YEAR		CE 7		-4 (
			MOUT					
	LEAKS DETEC	TED (Attach	T			ve Action		
Location Description	on Date Detected	Date Repaired	4	mera Model D for Rescan	Descriptio	n <u>For Each</u> empt		
1 BY MUSE BUSHI	سند المواسي	9-26-17	, ,	X 320 14900182	RE-TAPED	& TIGHTEMA RUSHING

Gauge Bushing Leak

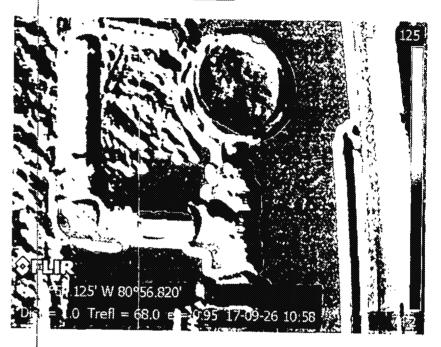
Gauge Bushing Repair
